HOAI Webinar 2025 series

Highway Health Check: Mastering Pavement Distress & NSV 6th May 2025

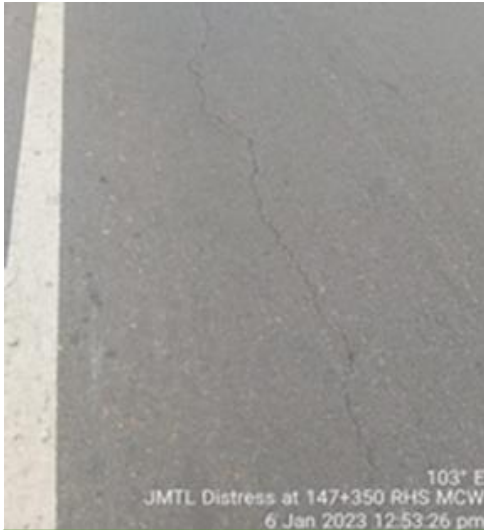
Longitudinal Cracks

Cracks parallel to direction of traffic movement

- Poor joint matching
- Reflective cracks
- HMA Fatigue (onset of alligator cracks)

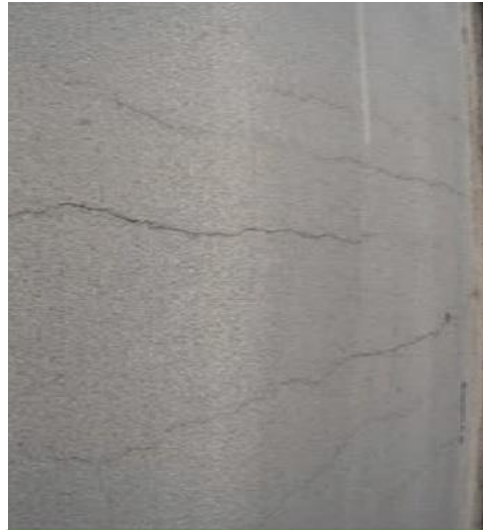
Transverse Cracks

Cracks perpendicular to pavement centreline

- Shrinkage of HMA due to low temperatures or asphalt binder hardening
- Reflective cracks

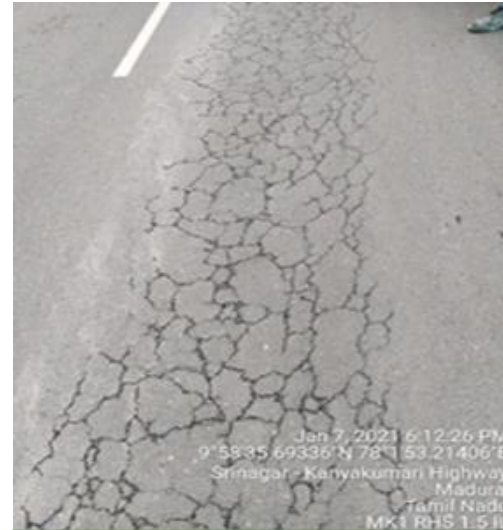
Alligator Cracks

Series of interconnected cracks which are caused by fatigue failure of HMA under repeated traffic loading.

- Overloaded traffic
- Inadequate structural design
- Stripping at bottom of HMA

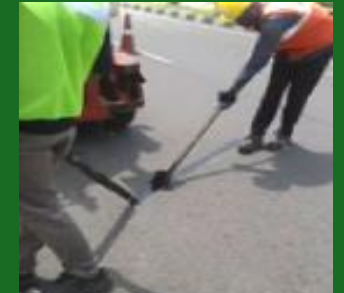
Crack seal with hot bitumen sealant

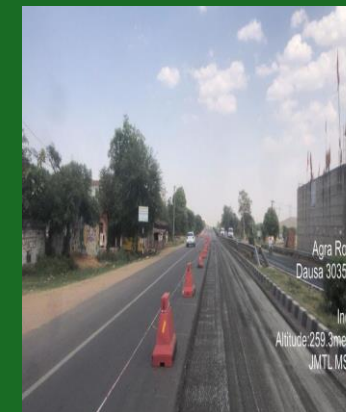
High Severity Cracks (>6mm wide cracks)

Remove and replace the cracked pavement layer with fresh overlay

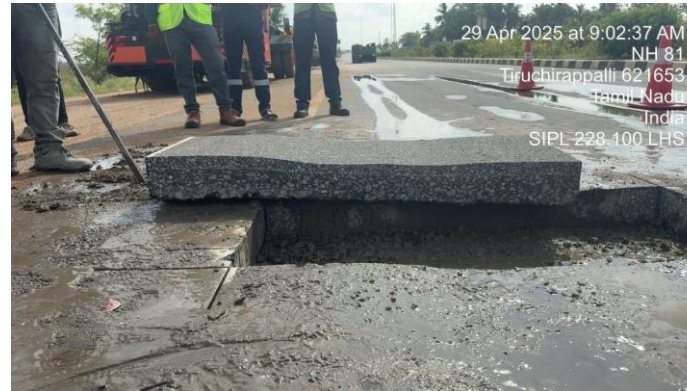
Rutting developed only on top bituminous layers

Distress: Rutting

Surface depression in the wheel path.

It can either be mix rutting which is restricted to the top layer or sub grade rutting which is majorly due to settlement of subgrade/ underlying layers

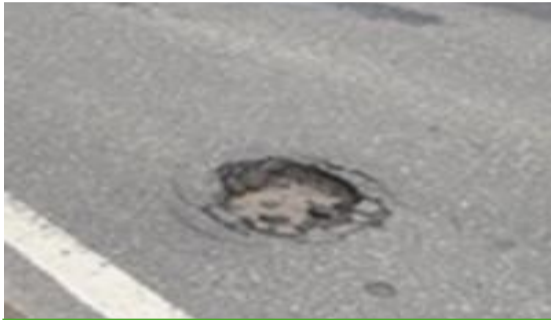
Potholes

Small depressions in the pavement surface that penetrate all the way through HMA Layer. In can be end result of alligator cracks

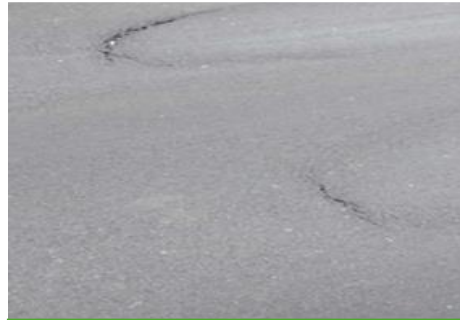
Slippage

Crescent shaped cracks generally having two end pointed into the direction of traffic

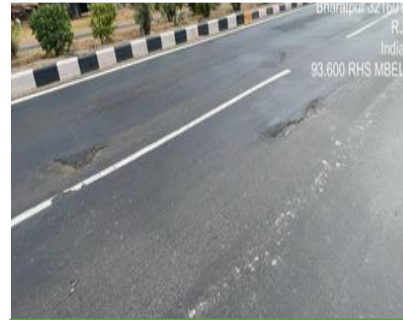
Shoving

Plastic movement of bituminous layer due to which a pavement surface bulges out and forms wave

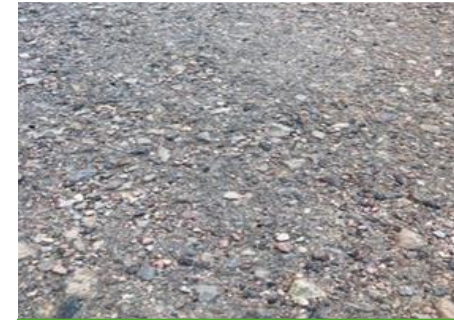
Ravelling

Dislodgement of aggregate particles.

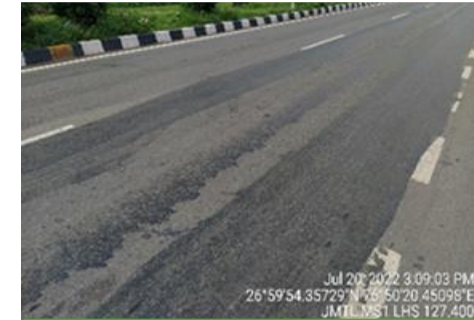
Bleeding

Film of asphalt binder on the pavement surface. Creates a shiny, glass-like reflecting surface that can become quite sticky.

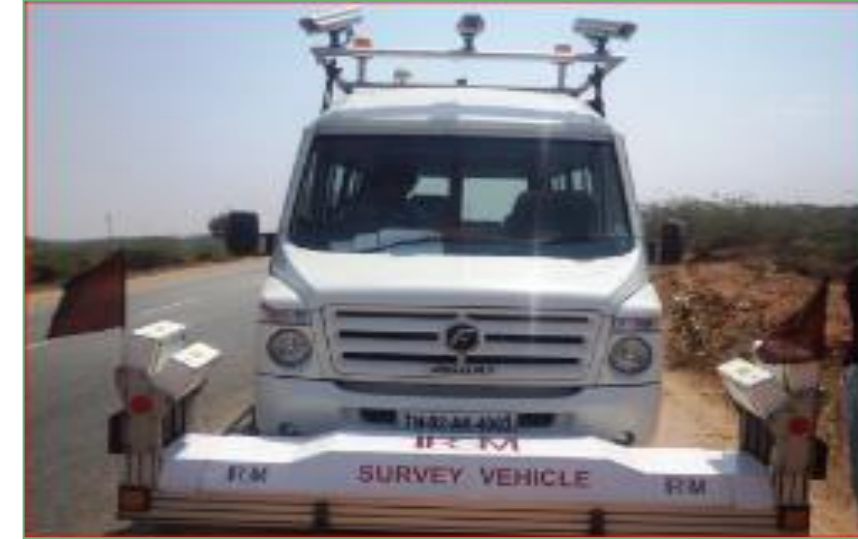
- NSV survey is a method for automatically collecting road condition data including pavement distresses and road inventory details at highway speeds
- The system can capture:
 - Transverse Profile (Rut depth)
 - Longitudinal Profile (Roughness)
 - Pavement distresses by video imaging (cracks, patching, potholes, etc.)
 - Pavement texture
 - Road Geometry Data (Cross slope, gradient, curvature)
 - GPS Coordinates
 - Road furniture using video imaging
- Digital Laser Profiler (DLP) integrated into the NSV and consists of eleven lasers. The profiler is capable of measuring:
 - Pavement roughness (one laser in each wheel path)
 - Rutting (full transverse pavement measurement)
 - Macro Texture (outer and inner wheel paths)

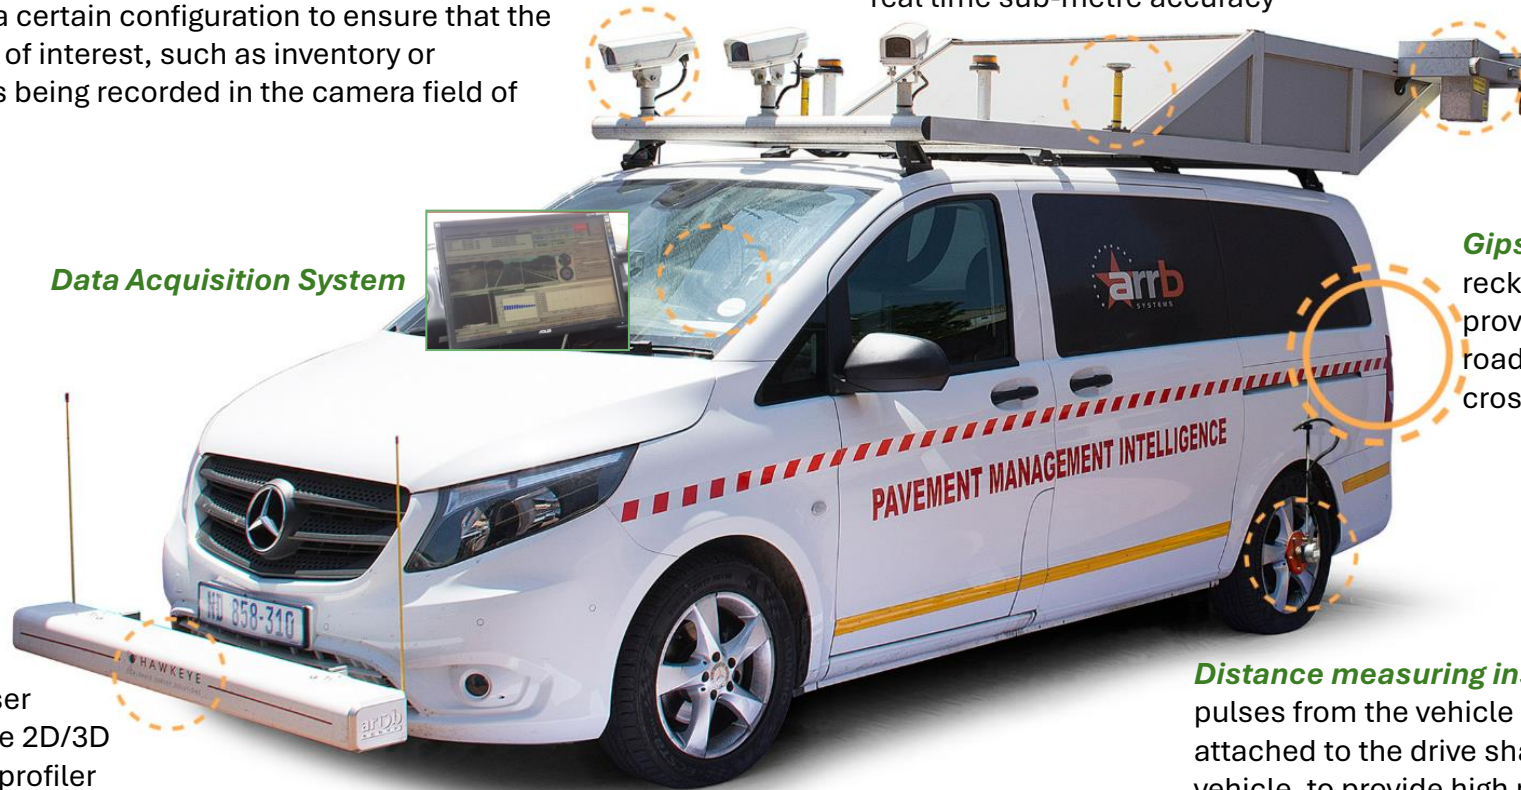
Components of NSV survey

Digital imaging system: These cameras are oriented in a certain configuration to ensure that the information of interest, such as inventory or condition, is being recorded in the camera field of view.

GNSS - GPS provides an accuracy of 5m-15m, while DGPS achieves real time sub-metre accuracy

Gipsi-Trac Geometry: It uses dead reckoning sensors and GPS data to provide continuous highway maps and road geometry information such as cross slope, grade, and curvature.

Digital laser profile: It uses laser sensors to accurately record the 2D/3D profile of the road surface. The profiler can measure roughness, rutting and pavement texture.

Distance measuring instrument: It uses distance pulses from the vehicle odometer system, or a sensor attached to the drive shaft or a wheel of the survey vehicle, to provide high resolution speed and distance data. Each road inventory and pavement condition parameter will be referenced to the road running distance.

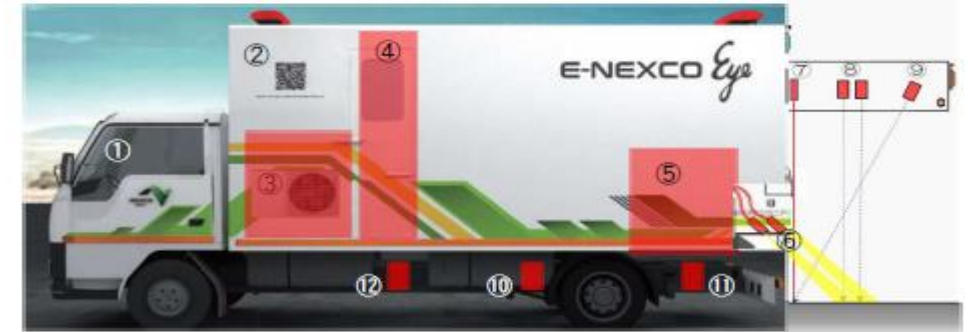
E-NEXCO Eye

- Developed jointly by **NEXCO East** and **Cube Highways** for Indian conditions
- Capable of measuring Roughness (IRI), Rutting and Pavement distresses accurately when running at a speed of 100km/hr
- Roughness is measured using three line sensors in a lane
- Rutting is measured with an accuracy of 1mm and can gather road profile 1mm laterally and 1cm longitudinally
- Capable to take pictures with a clarity equivalent to 1800-million-pixel image by area camera to determine pavement distresses accurately

①	Driver's Area	⑦	High Power Laser
②	Monitor & Key Board (for Operation)	⑧	Color Line Sensor Cameras for Pavement (2)
③	Electric Power Generator	⑨	Multi Scan 3D Camera
④	PC Rack	⑩	Laser Displacement Meter
⑤	Light Source	⑪	3D Inspection Equipment Integrated with Laser Camera
⑥	Irradiation Unit for Pavement (8 lamps)	⑫	Non-Contact Distance Meter
